CASE STUDY

LINK-PIPE INC.'s LINK-PIPE GROUTING SLEEVE™ LOCAL REPAIR SYSTEM

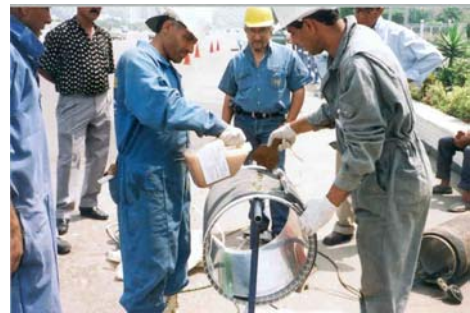
The system comprises a stainless steel structural core which uses a mechanical lock to hold it against the host pipe, absorbent foam gasket surrounding the core, and limit straps to prevent overloading the host pipe.

The annular space around the structural core is filled with a polyurethane gasket, impregnated with grout on site. The liner is located at the defect area and an inflatable packer used to expand the sleeve until the locking devices engage. A foam grout expands to fill the annular space and penetrates pipe cracks. The complete system for a composite structure with the host pipe.
